Digital Inventory of Landslides and Related Deposits in Honduras Triggered by Hurricane Mitch

By Edwin L. Harp, Kirk W. Hagaman, Matthew D. Held, and Jonathan P. McKenna

Open-File Report 02-61

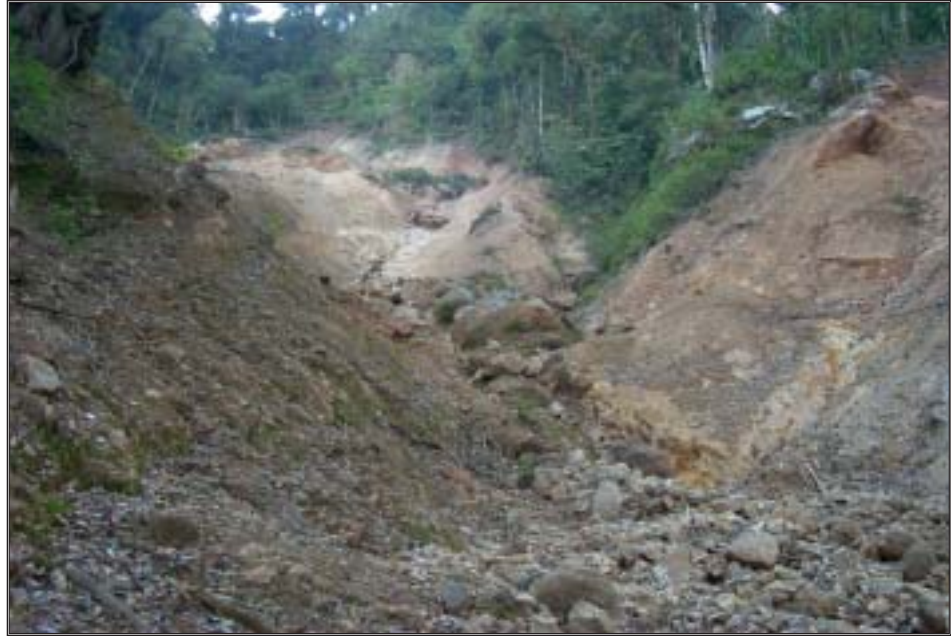
Figure 2.
Headscarp of
Cerro de Uyuca
debris flow.

to greater depths, and debris flows attained commensurately greater thicknesses. In many cases, debris flows have cut into weathered volcanic rocks to depths of 15 m, and the debris flows were more confined to stream channels and gullies, many of which have long run out distances of several kilometers or greater. Southeast of Zamorano in the San Buenaventura Valley, numerous debris flows exceeded 4 km in length. The longest debris flow in Honduras triggered by Hurricane Mitch originated in the cloud forest high on the slopes of Cerro de Uyuca (figure 2) and traveled for 7.5 km. At the distal end of this flow, 68 dwellings were destroyed in the village of El Jicarito (figure 3).

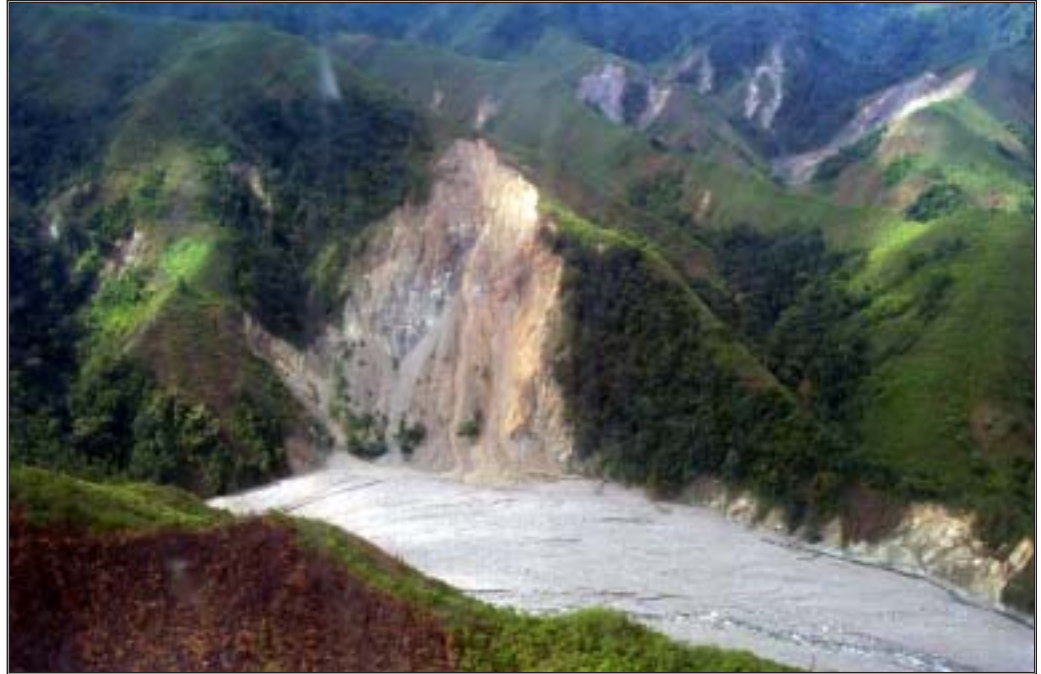
Figure 5. Airphoto of sediment stream produced by debris flows in the Río Viejo, a tributary of the Río Cangrejál that flows through La Ceiba.

gered by Hurricane Mitch in this drainage are fully linked to the stream system and have completely filled the flood plain of the Río Viejo (fig. 5). The average diameter of the sediment produced is extremely coarse with almost no silt or finer size fraction present (figure 11). At present, three years after the hurricane, debris flows in the Río Viejo drainage still have significant volumes of material that will enter the stream system.

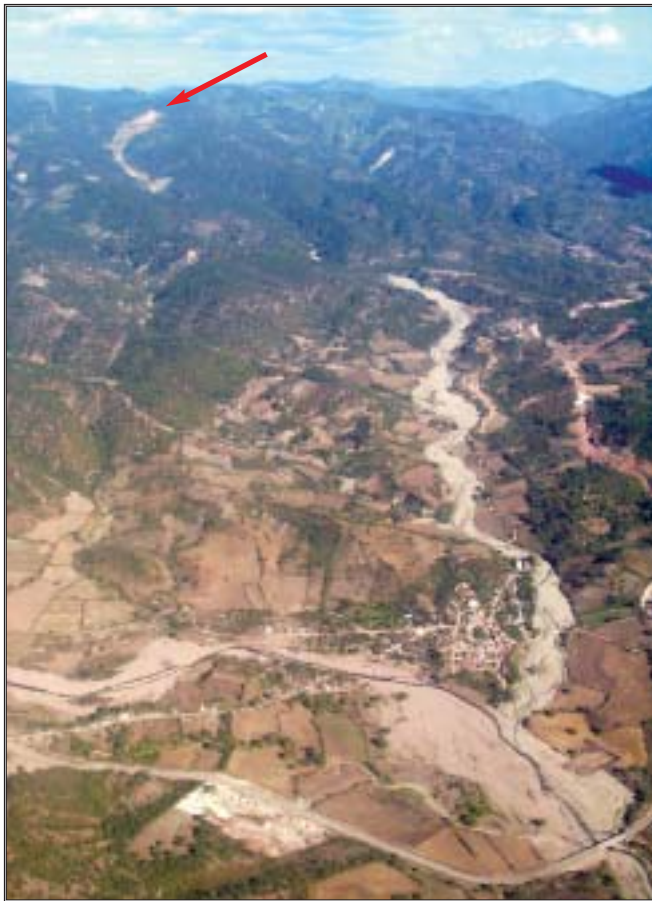
Figure 6. Aerial view of the village of Marale in the right foreground and the sediment stream produced by a large rotational slump in the distance (arrow).

tion caused by the landslides than from the landslides themselves. Large sediment streams choking the rivers that flow near these population centers have caused avulsion of the rivers and diversion of flood waters into residential areas. In La Ceiba, El Progreso, and La Libertád, extremely large concentrations of debris flows and debris slides in the watersheds upstream from these centers have inundated the streams with sediment that will cause flooding and stream diversion problems for years to come (figure 5). Similar problems in the village of Marale in central Honduras were caused by one large rotational slump that provided debris to the stream that flows next to the village (figure 6).

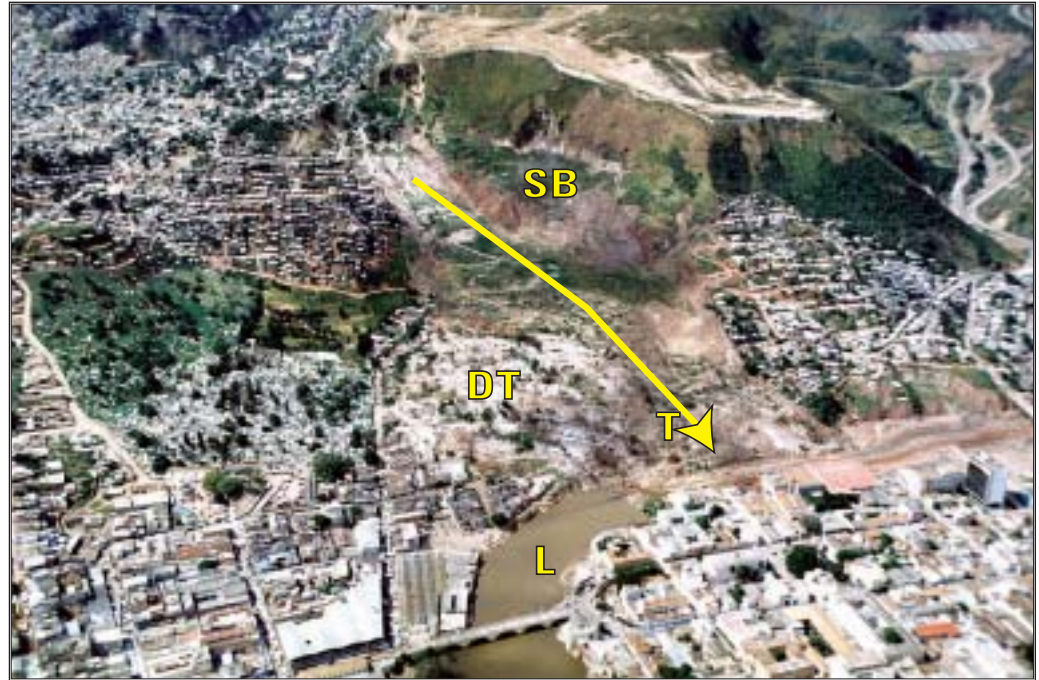
Figure 7. Aerial view of the El Berrinche landslide, a complex rotational slump/earth flow that dammed the Río Choluteca in Tegucigalpa. The arrow indicates the direction of movement of the earth-flow tongue. "T" denotes the toe of the landslide that dammed the river, and "L" indicates the lagoon dammed by the toe of the landslide.

Although small in number, deep-seated landslides had an extremely large impact on people and property due to the fact that many of them occurred in heavily populated areas. The largest of the landslides in this category triggered by Hurricane Mitch occurred in Tegucigalpa, destroying a portion of the central part of the city known as Colonia Soto and damming the Río Choluteca, creating a sewage-filled lagoon upstream from the landslide dam (figure 7). This complex slump/earth flow had a volume of approximately 6 million cubic meters. Because of previous slow movement of the landslide, city residents living on the landslide mass were evacuated prior to its rapid movement that culminated in the damming of the river. The river was dammed at approximately 12:30 a.m. on October 31, about 1 hour after the peak flood flow of the Río Choluteca.

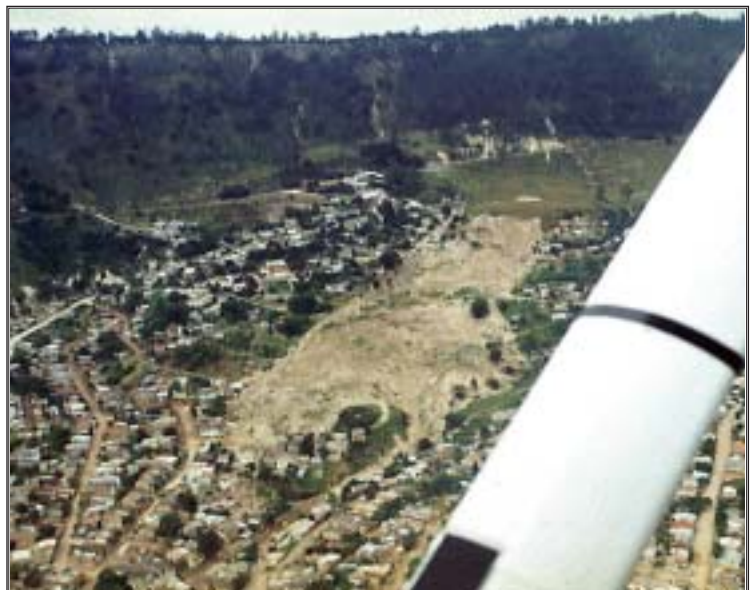
Figure 8. Aerial view of the El Reparto slump/debris flow.

Another deep-seated landslide, a rotational slump/debris flow with a volume of 400,000 m³ destroyed numerous houses in the Colonia El Reparto section of Tegucigalpa (figure 8). This landslide occurred on October 31 during the mid-morning hours over a timespan of several hours. The final movement of the slump resulted in the formation of a debris flow, which mobilized from the oversteepened toe of the landslide and demolished the houses.

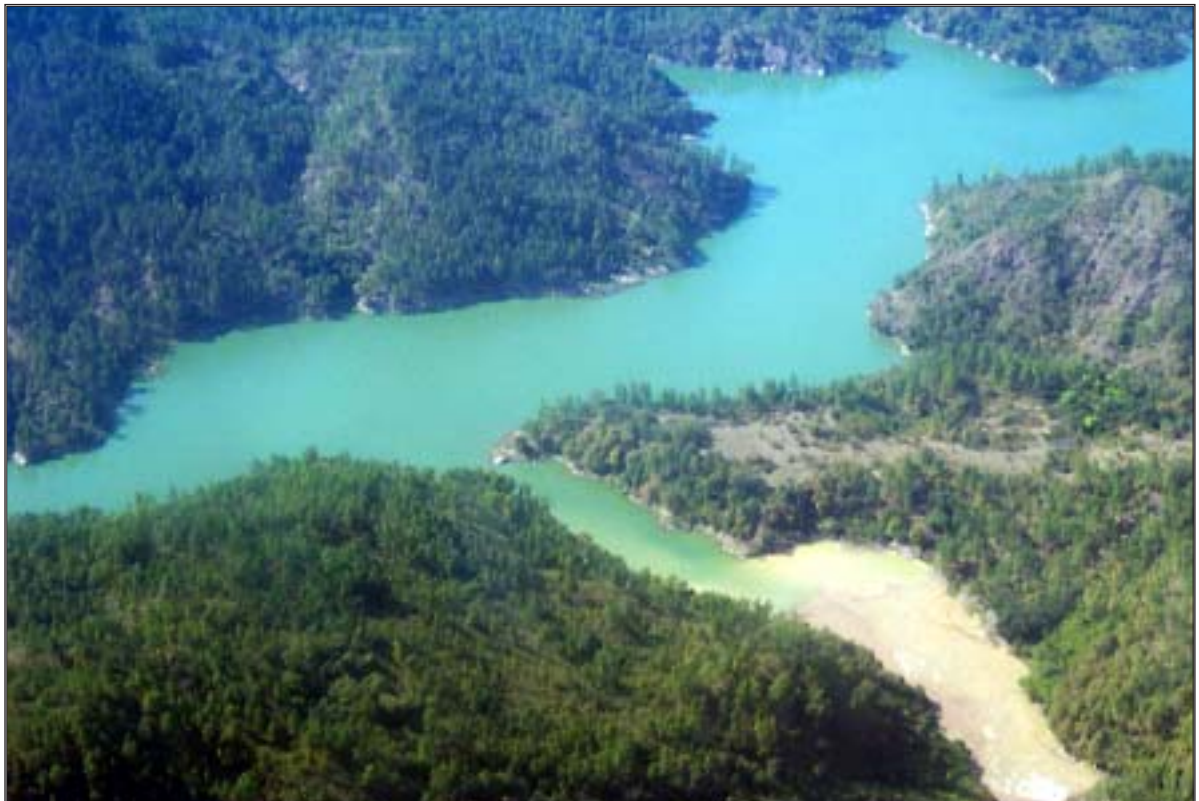
Figure 10. Aerial view of sediment stream produced by debris flows near La Libertád. Sediment is shown here flowing down the Río Quirima and into El Cajón Reservoir. Light area in lower right arm of reservoir is almost entirely sediment.

Areas of highly concentrated debris flows in the headwaters of the Río Quirima and Río Frío (figure 15) served to destroy many homes that were located in the flood plain of the Río Frío near La Libertád and to send a large stream of sediment down the Río Quirima where it is filling in the arm of El Cajón reservoir where this stream joins the reservoir (figure 10).

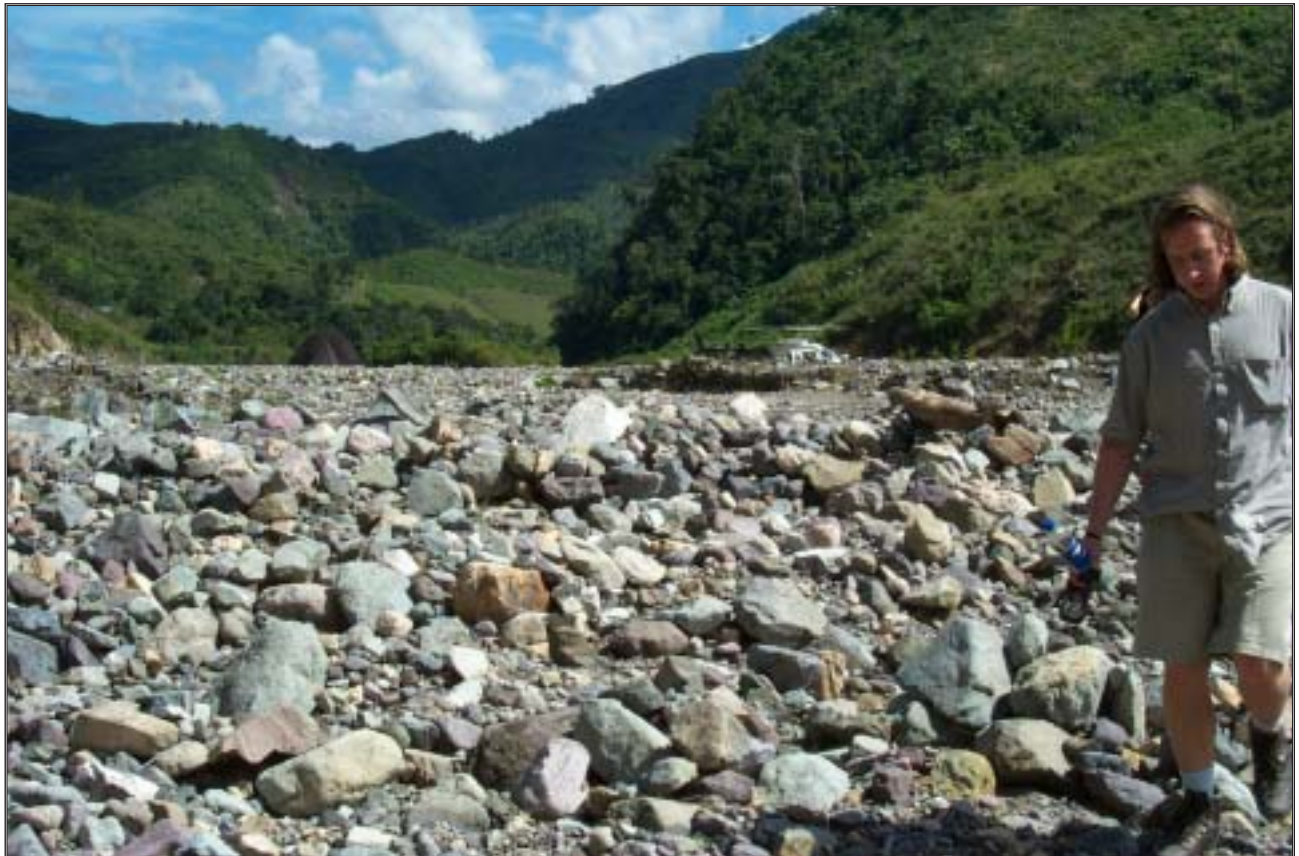
Figure 11. View of Río Viejo flood plain showing coarse nature of sediment.

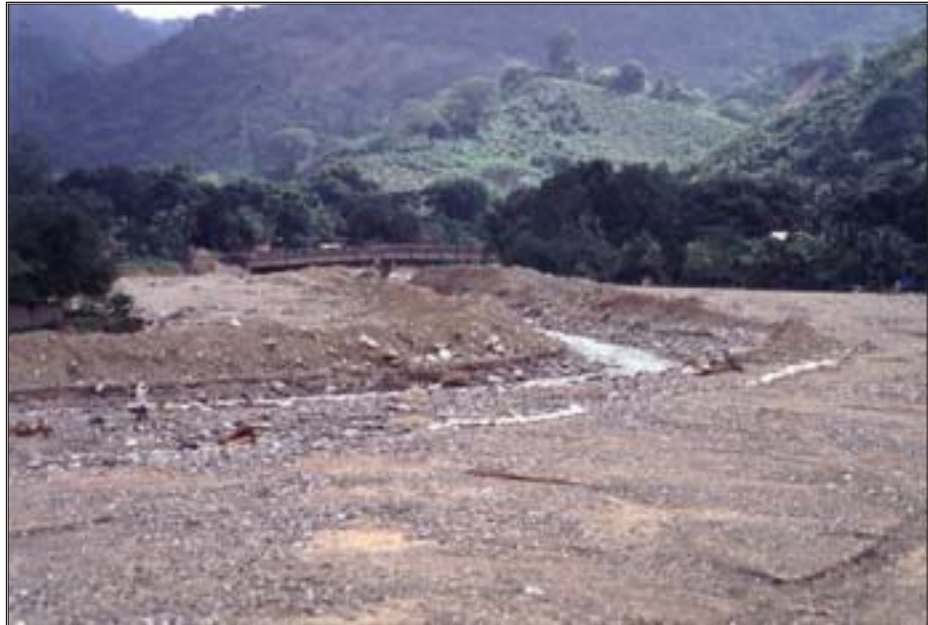
Figure 12. Upstream view of Río Pelo flood plain in El Progreso in January 1999 showing inundation of the river's channel with sediment derived primarily from erosion-induced channel scour in the upstream watershed during Hurricane Mitch.

Sediment volume: 312,000 m³. The volume of sediment produced by landslides in this quadrangle and, in particular, the Río Pelo watershed is far too small to account for the inundation of alluvial sediment that affected the river channel where it passes through the city of El Progreso (figure 12). With so few landslides evident from post-Mitch aerial photography of the Río Pelo watershed, the conclusion is that the sediment was derived mainly from erosion-induced channel scour.

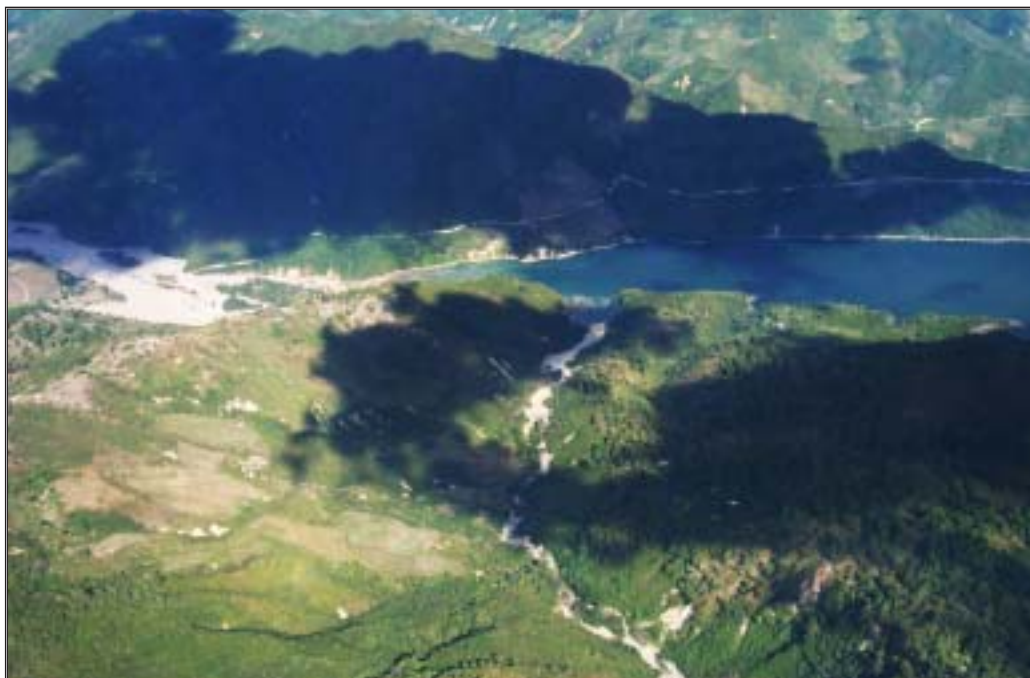
Figure 13. Stream of sediment mainly from landslides being deposited into arm of El Cajón Reservoir.

Sediment volume: 4,520,000 m³. Landslides in the upper drainages of streams that flow into El Cajón Reservoir have created two 5-km-long streams of sediment that merge and have deposited large volumes of sediment into the reservoir (Plate 6, figure 13). The headwaters of the Río Chilistagua and Quebrada de Yorito have hundreds of debris flows and several large deep-seated slump/debris flows (figure 14) that are well-linked to the stream network.

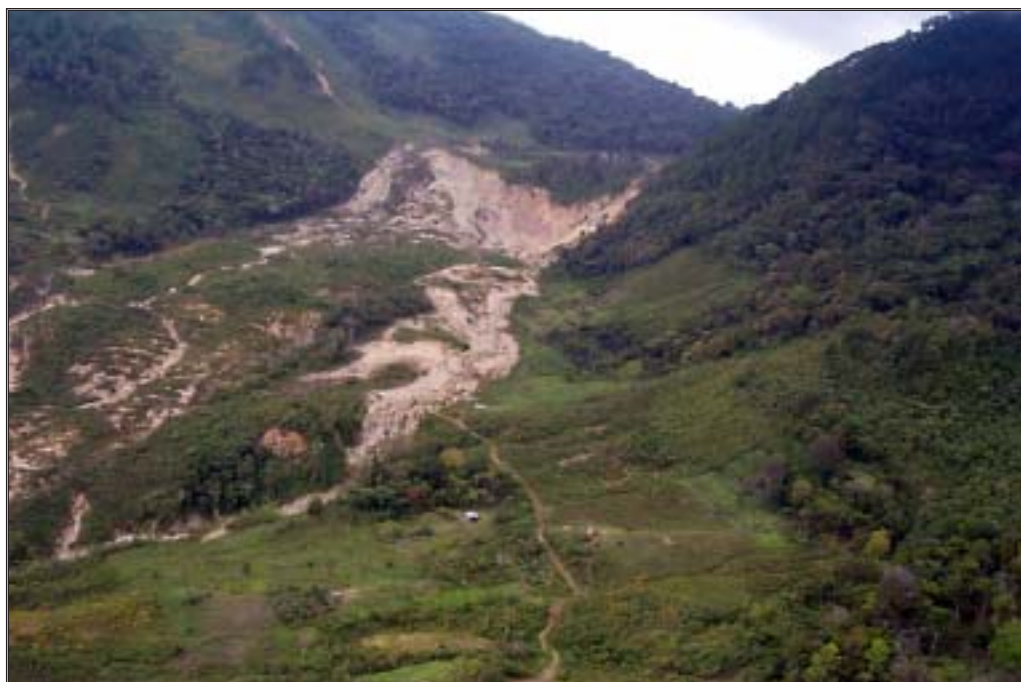
Figure 14. Deep-seated slump/debris flow in the headwaters of Río Chilistagua above El Cajón reservoir.

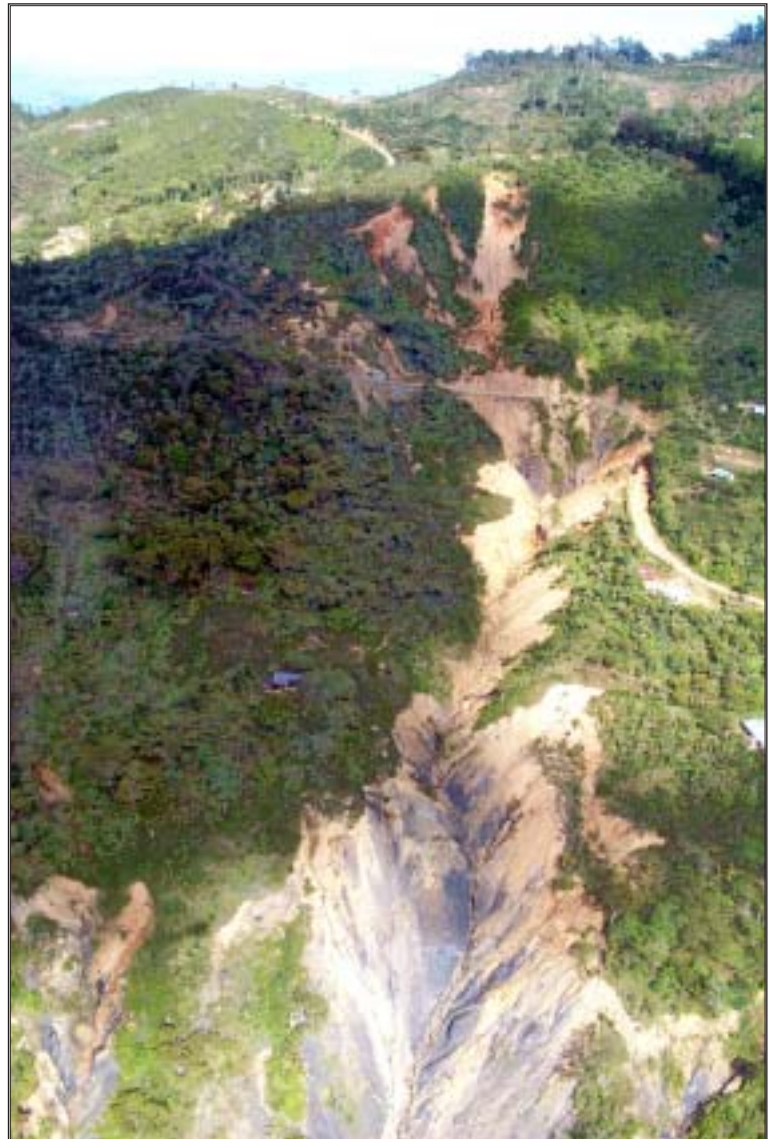
Figure 15. Oblique airphoto showing typical debris-flow concentrations in headwaters of Río Frío and Río Quirima.

ties and destruction of homes occurred in the headwaters of many streams such as the area shown in figure 15. Here, several homes can be seen close to the margins of many of the debris flow scarps. Although these homes escaped direct impact from debris flows, numerous others did not in this and other mountainous areas throughout Honduras. Debris flows triggered by Hurricane Mitch in similar mountain communities typically destroyed between 5 and 20 homes where debris flows were highly concentrated by heavy rainfall and susceptible geologic units.
